Naval Facilities Engineering Command

NAVFAC MO-102.1

Maintenance & Repair Alternatives Pavement Condition Index (PCI) Field Manual November 1988

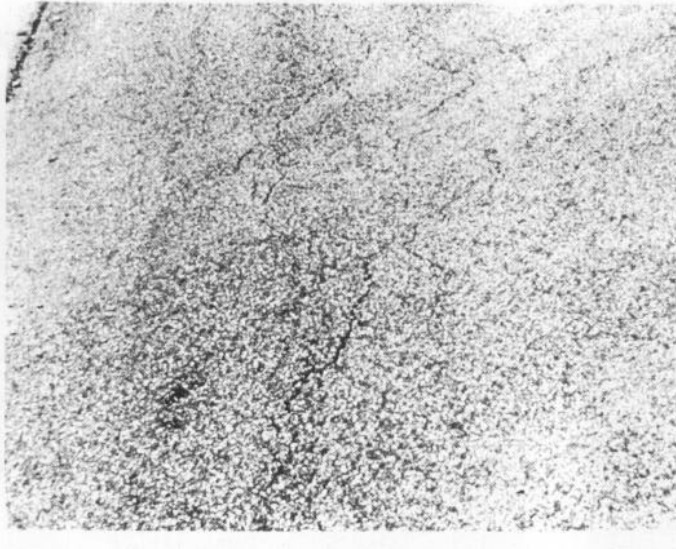
Figure 2. Low-severity alligator cracking

Figure 3. Low-severity alligator cracking

L - Fine, longitudinal hairline cracks running parallel to each other with none or only a few interconnecting cracks. The cracks are not spalled.* (Figures 2 and 3)

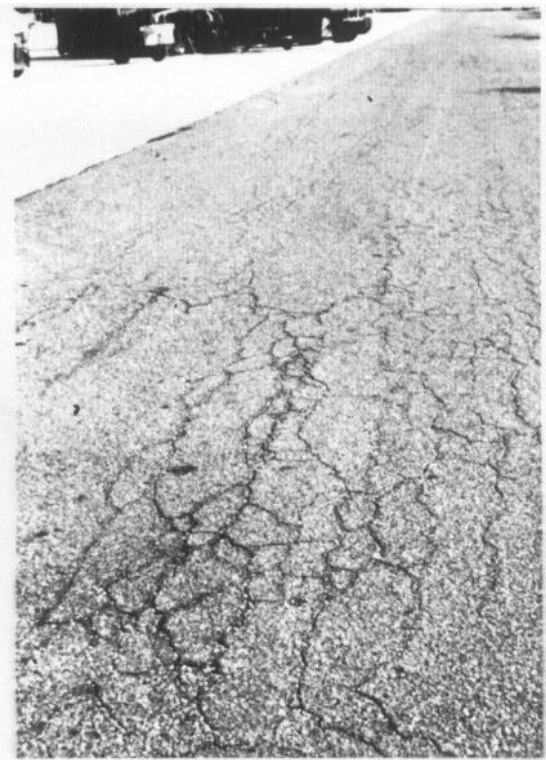
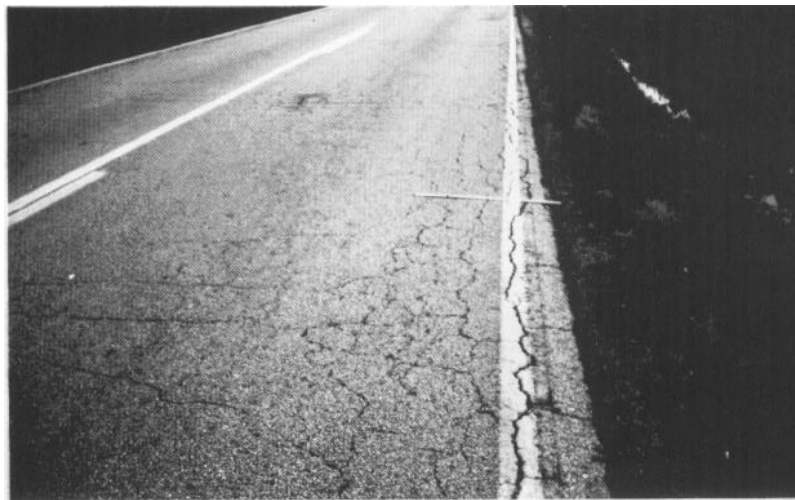
Figure 4. Medium-severity alligator cracking

Figure 5. Medium-severity alligator cracking

Figure 6. Medium-severity alligator cracking

M - Further development of light alligator cracks into a pattern or network of cracks that may be lightly spalled. (Figures 4, 5, and 6)

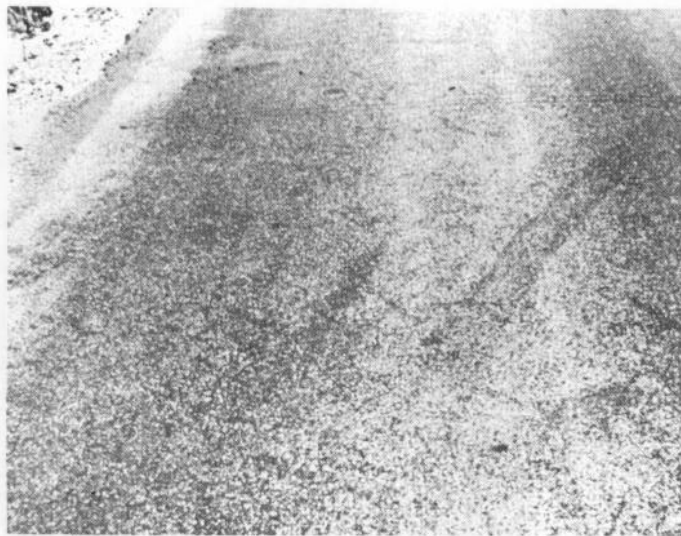
Figure 9. Low-severity bleeding

L - Bleeding has only occurred to a very slight degree and it is noticeable only during a few days of the year. Asphalt does not stick to shoes or vehicles (Figure 9)

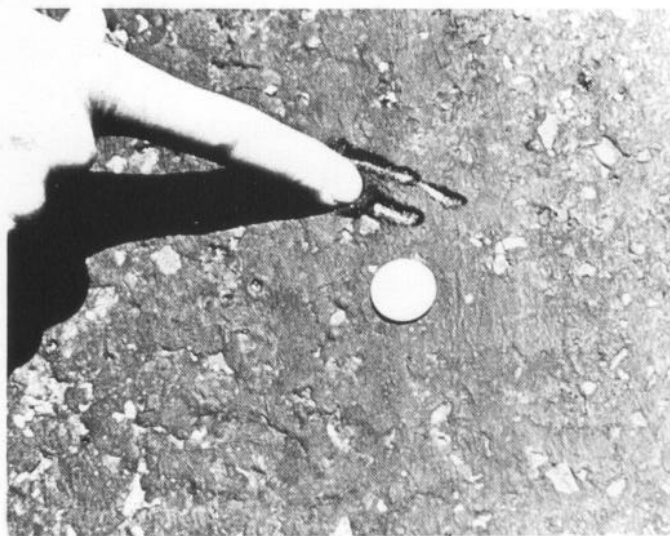
Figure 10. Medium-severity bleeding

M - Bleeding has occurred to the extent that asphalt sticks to shoes and vehicles during only a few weeks of the year. (Figure 10)

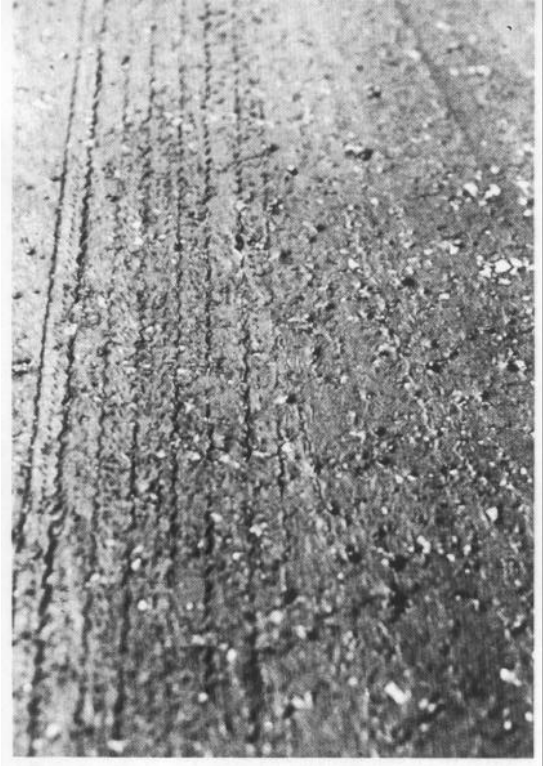
Figure 11. High-severity bleeding

H - Bleeding has occurred extensively and considerable asphalt sticks to shoes and vehicles during at least several weeks of the year. (Figure 11)

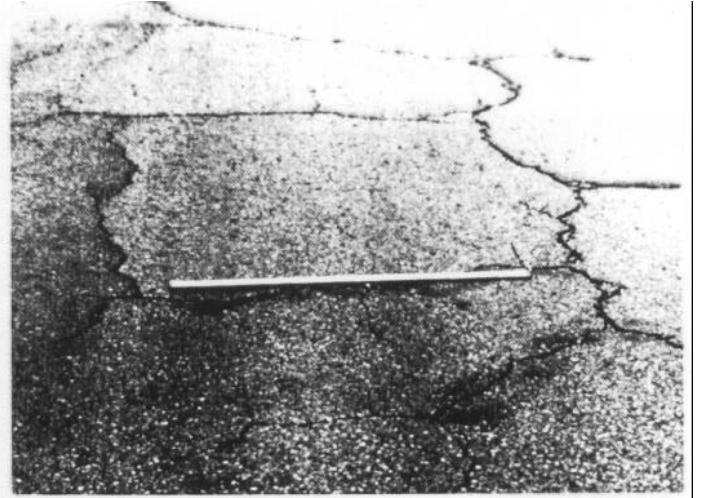
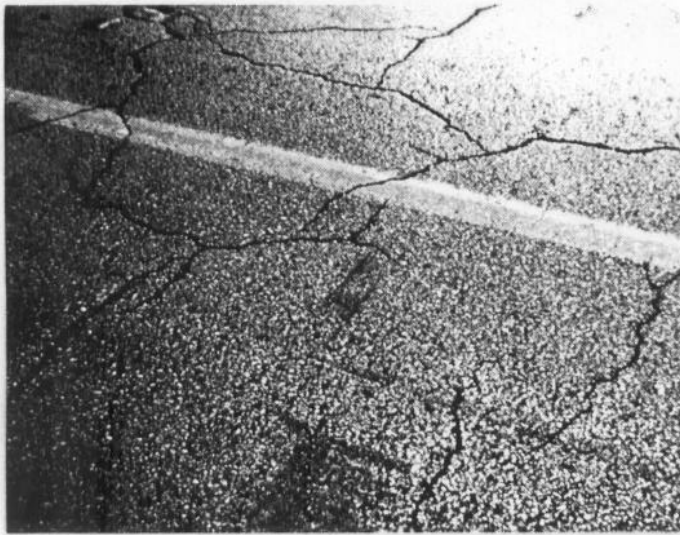
Figure 13. Medium-severity block cracking

Figure 14. Medium-severity block cracking

M - Blocks are defined by medium-severity* cracks. (Figures 13 and 14)

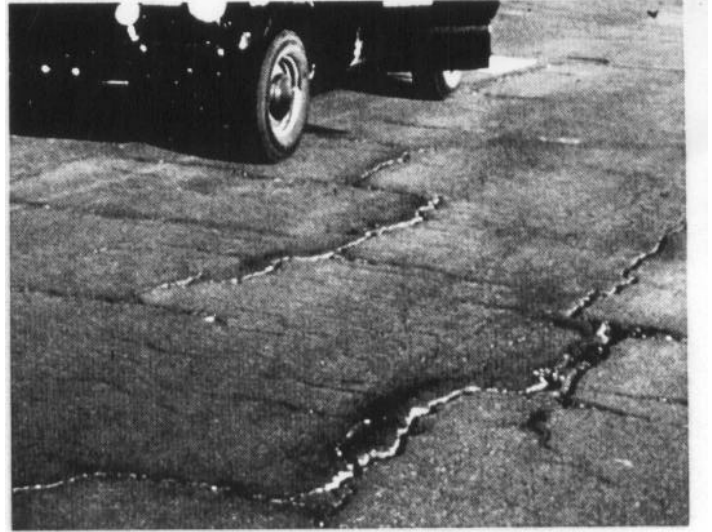
Figure 15. High-severity block cracking (a few inches around the crack are severely broken)

H - Blocks are defined by high-severity cracks. (Figure 15)

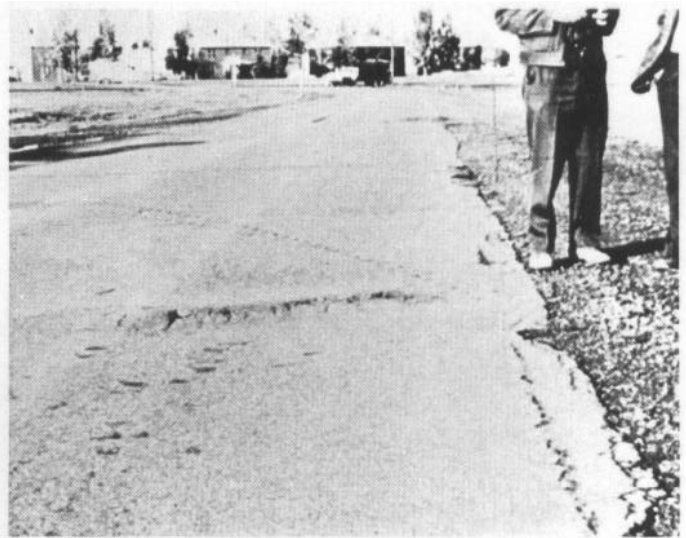
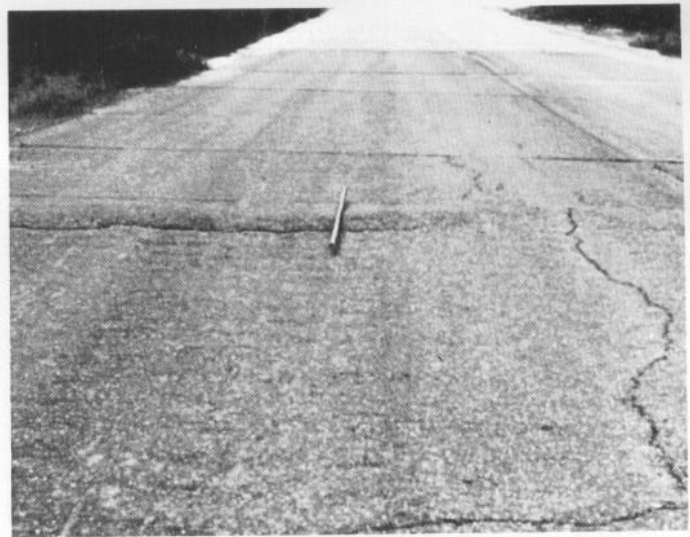
Figure 17. Medium-severity bumps and sags

Figure 18. Medium-severity bumps and sags

Figure 19. Medium-severity bumps and sags

M - Bump or sag causes medium-severity ride quality. (Figures 17, 18, and 19)

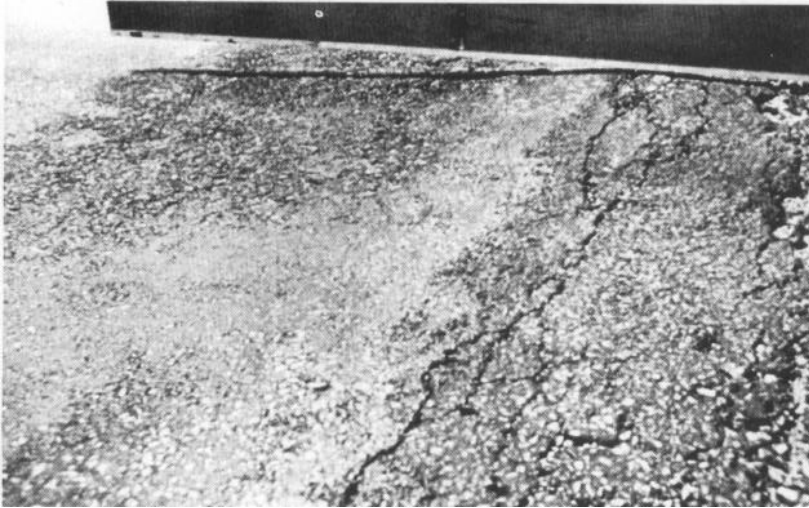
Figure 20. High-severity bumps and sags

H - Bump or sag causes high-severity ride quality. (Figure 20)

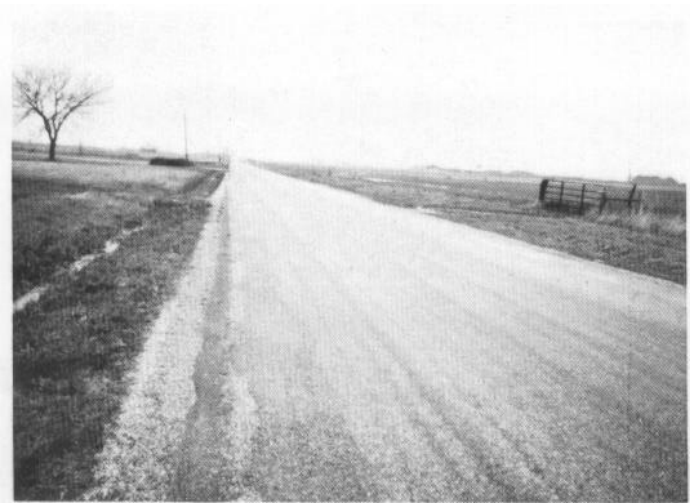
Figure 21. Low-severity corrugation

Levels: L - Corrugation produces low-severity ride quality. (Figure 21)

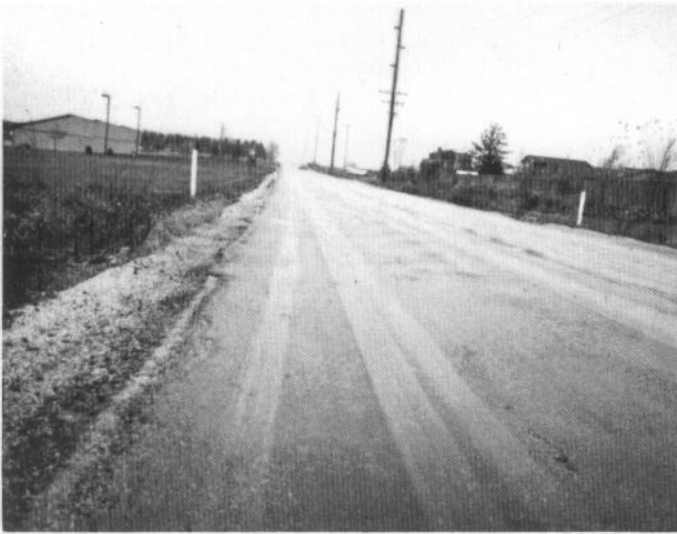
Figure 22. Medium-severity corrugation

Figure 23. Medium-severity corrugation

M - Corrugation produces medium-severity ride quality. (Figures 22 and 23)

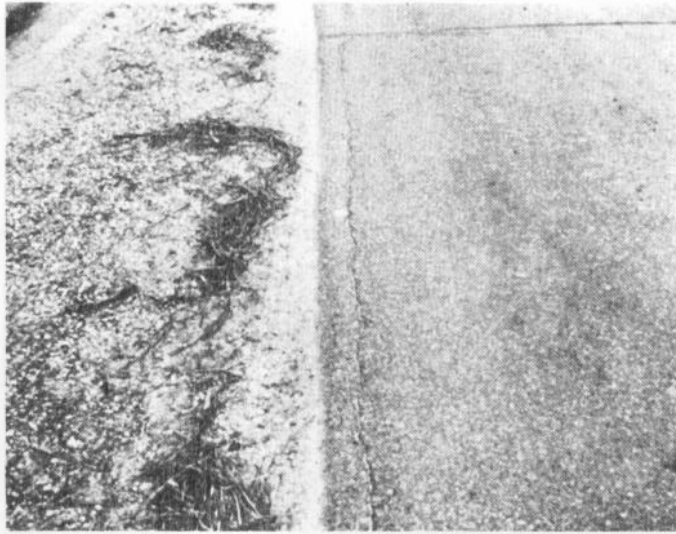
Figure 28. Low-severity edge cracking

Levels: L - Low or medium cracking with no breakup or raveling. (Figure 28)

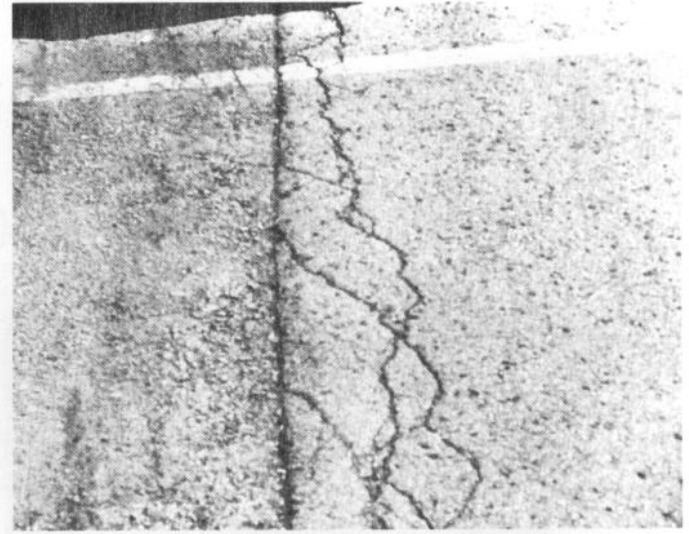
Figure 29. Medium-severity edge cracking

M - Medium cracks with some breakup and raveling. (Figure 29)

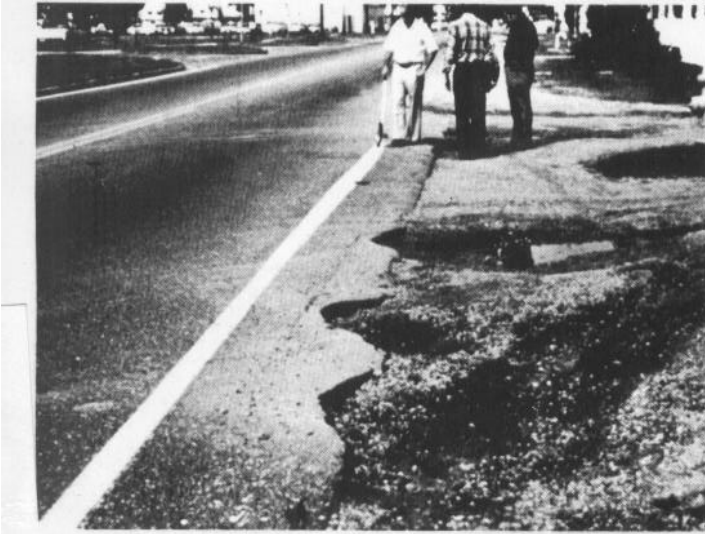
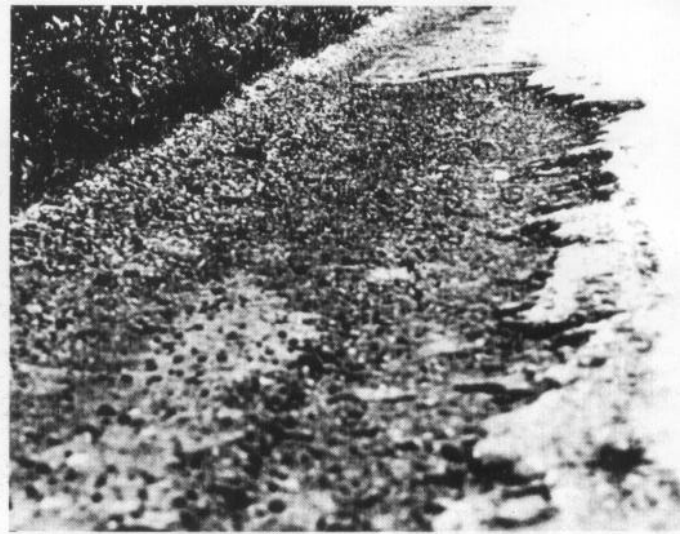
Figure 30. High-severity edge cracking

Figure 31. High-severity edge cracking

H - Considerable breakup or raveling along the edge. (Figures 30 and 31)

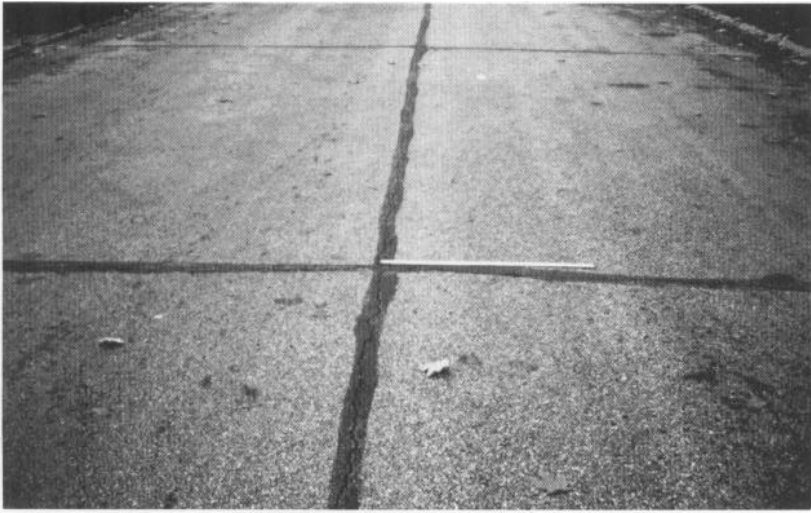
Figure 32. Low-severity joint reflection cracking

- L - One of the following conditions exist (Figure 32):
 - 1. Nonfilled crack width is less than 3/8 in. (10 mm), or
 - 2. Filled crack of any width (filler in satisfactory condition).
- M - One of the following conditions exist (Figure 33):
 - 1. Nonfilled crack width is 3/8 to 3 in. (10 to 76 mm).
 - 2. Nonfilled crack of any width up to 3 in. (76 mm) surrounded by light random cracking (Figure 33).
 - 3. Filled crack of any width surrounded by light random cracking.
- H - One of the following conditions exist (Figure 34):
 - 1. Any crack filled or nonfilled surrounded by medium or high-severity random cracking.
 - 2. Nonfilled cracks over 3 in. (76 mm).
 - 3. A crack of any width where a few inches of pavement around a crack is severely broken. (Crack is severely broken.)

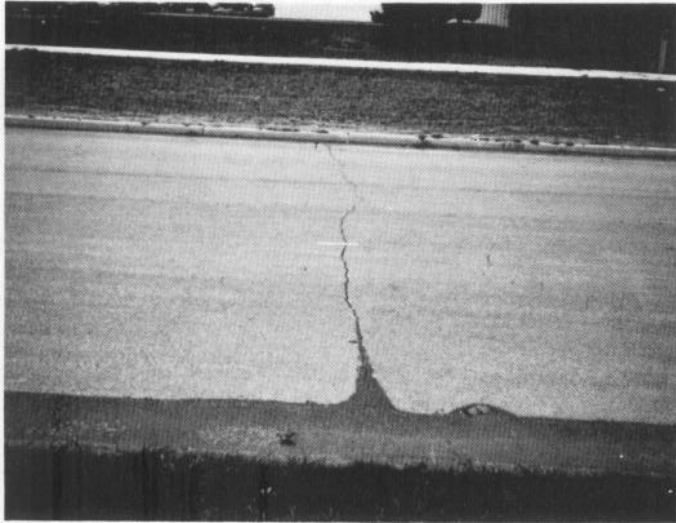
Figure 39. Low-severity longitudinal and transverse cracking

- L - One of the following conditions exist (see Figure 39):
 1. Nonfilled crack width is less than 3/8 in. (10 mm), or
 2. Filled crack of any width (filler in satisfactory condition).
- M - One of the following conditions exist (Figures 40 and 41):
 1. Nonfilled crack width is 3/8 to 3 in. (10 to 76 mm).
 2. Nonfilled crack of any width up to 3 in. (76 mm) surrounded by light and random cracking.
 3. Filled crack of any width surrounded by light random cracking.

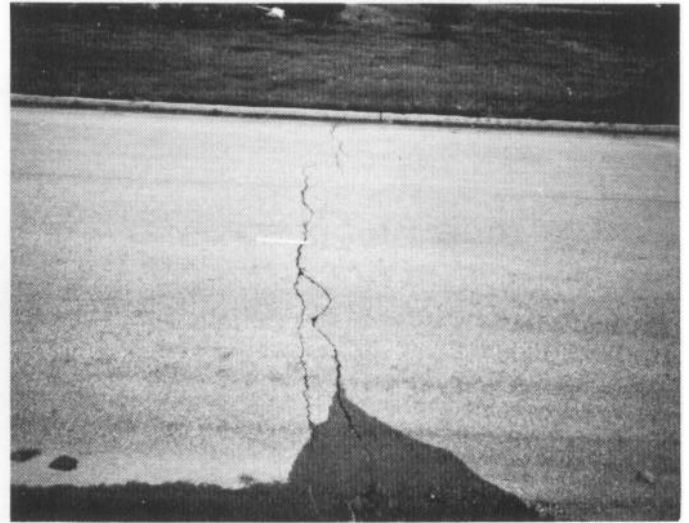
Figure 40. Medium-severity longitudinal and transverse cracking

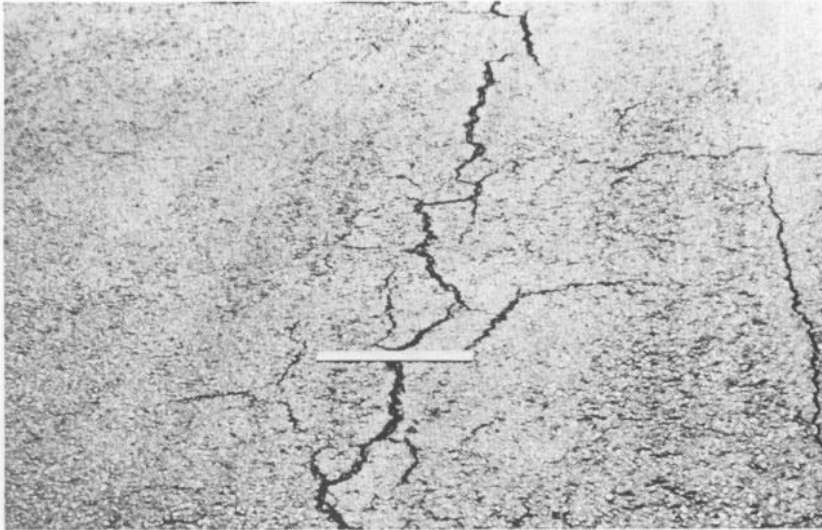
Figure 41. Medium-severity longitudinal and transverse cracking [$\frac{3}{4}$ in (19 mm) crack surrounded by light random cracks].

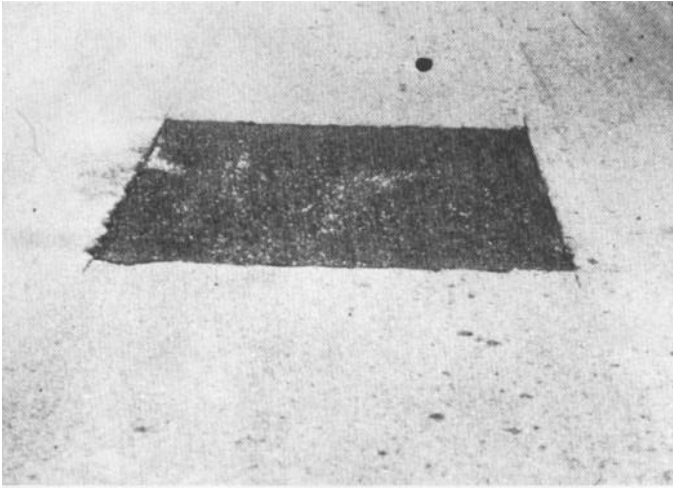
Figure 43. Low-severity patching and utility cut patching

L - Patch is in good condition and satisfactory. Ride quality is rated as low severity or better. (Figures 43, 44, and 45)

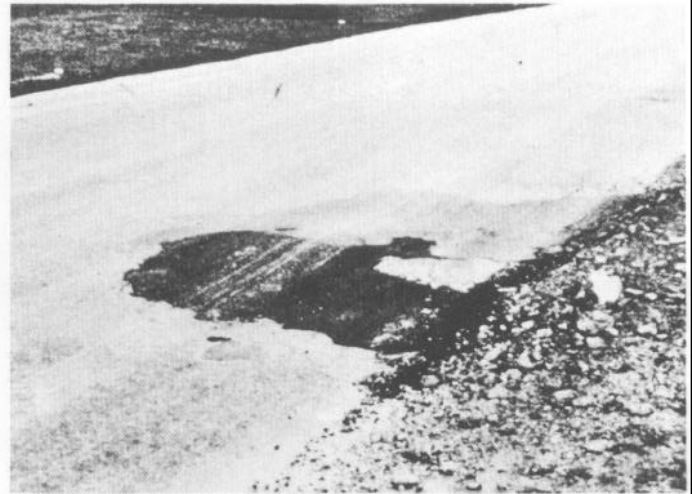
Figure 46. Medium-severity patch

M - Patch is moderately deteriorated and/or ride quality is rated as medium severity. (Figure 46)

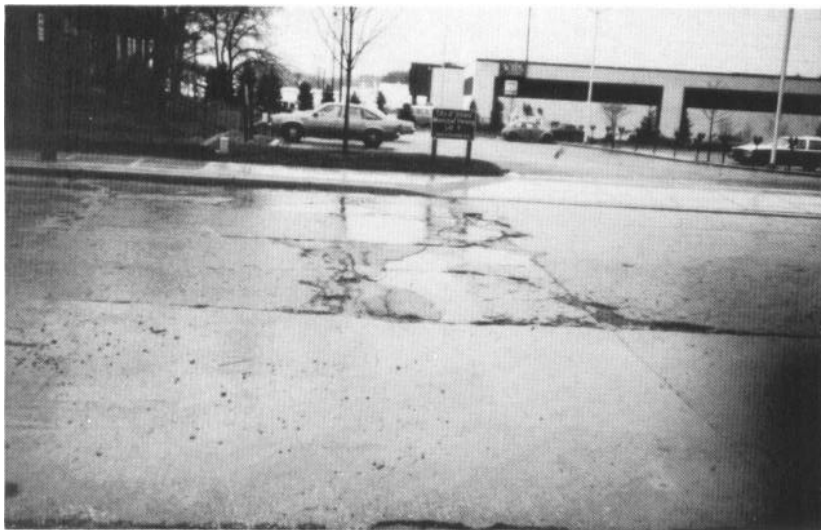
Figure 47. High-severity patching and utility cut patching

H - Patch is badly deteriorated and/or ride quality is rated as high severity. Patch needs replacement soon. (Figure 47)

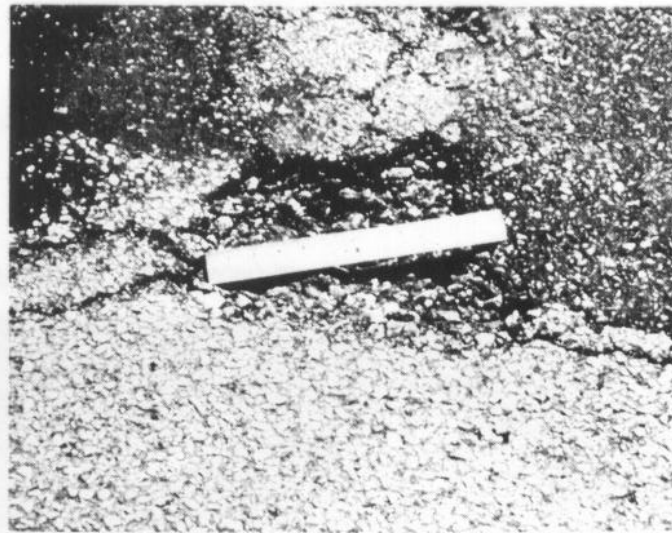
Figure 50. Low-severity pothole

If the pothole is over 30 in. (76 mm) in diameter, the area should be determined in square feet and divided by 5 sq ft (.47 square meters) to find the equivalent number of holes. If the depth is 1 in. (25 mm) or less, they are considered medium severity. If the depth is over 1 in. (25 mm), they are considered high severity. (Figures 49 through 53)

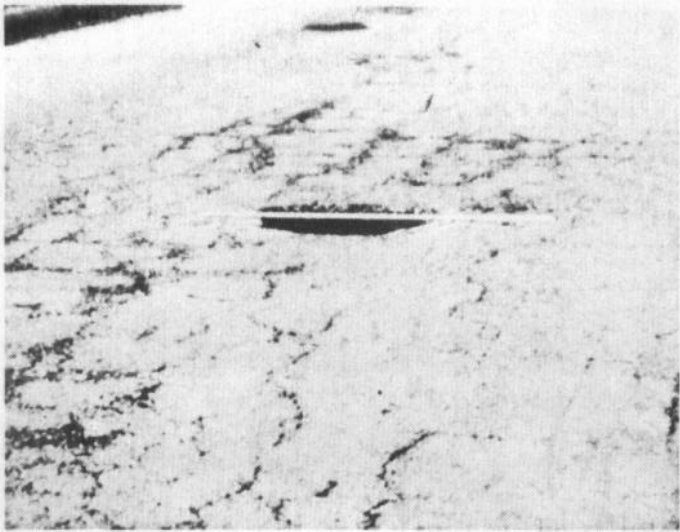
Figure 51. Medium-severity pothole

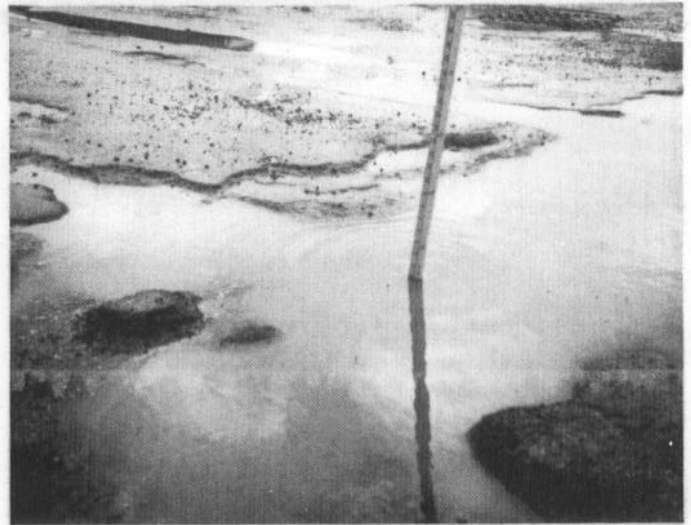
Figure 52. High-severity pothole

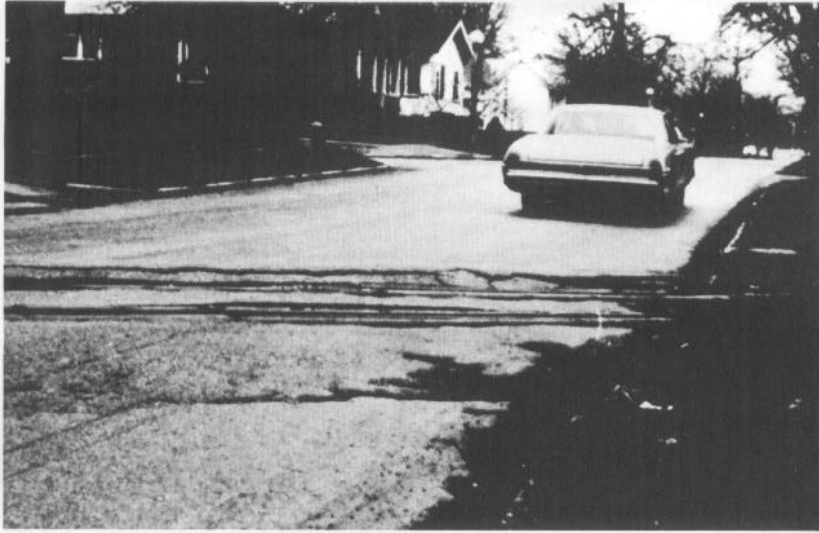
Figure 56. High-severity railroad crossing

- Levels:
- L - Railroad crossing causes low-severity ride quality. (Figure 54)
 - M - Railroad crossing causes medium-severity ride quality. (Figure 55)
 - H - Railroad crossing causes high-severity ride quality. (Figure 56)

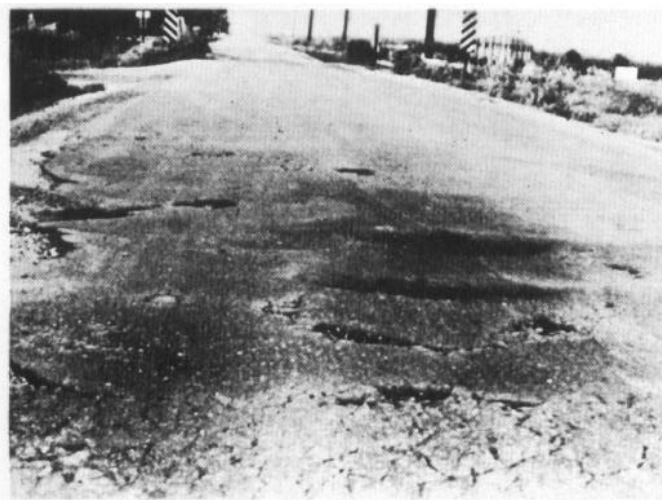
Figure 62. Medium-severity shoving approaching high severity

M - Shove causes medium-severity ride quality. (Figure 62)

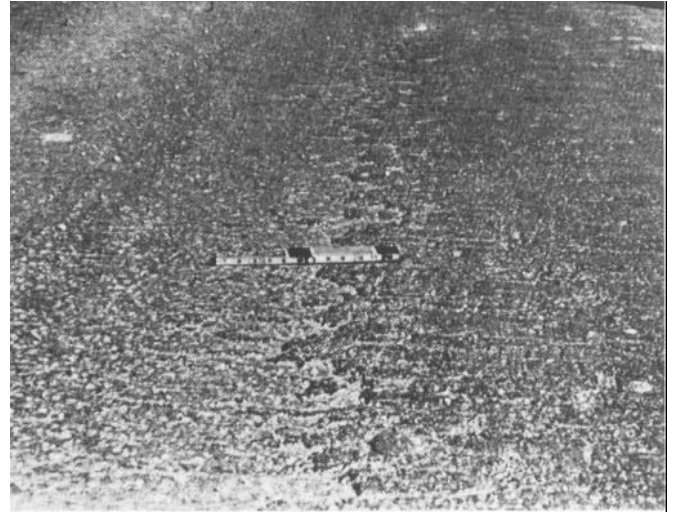
Figure 69. Low-severity weathering and raveling caused by tracked vehicles

L - Aggregate or binder has started to wear away. In some areas, the surface is starting to pit (Figures 68 and 69). In case of oil spillage, the oil stain can be seen, but the surface is hard and cannot be penetrated with a coin.

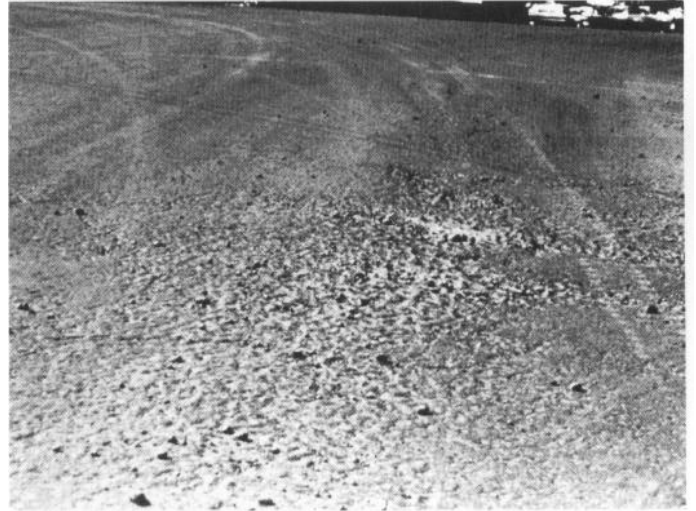
Figure 71. Medium-severity weathering and raveling

M -Aggregate and/or binder has worn away. The surface texture is moderately rough and pitted (Figures 70 and 71). In case of oil spillage, the surface is soft and can be penetrated with a coin.
